# LOST URBAN CREEKS

## Springbrook Creek Water Quality Monitoring Summary 2019/2020 Final Report

February 2021

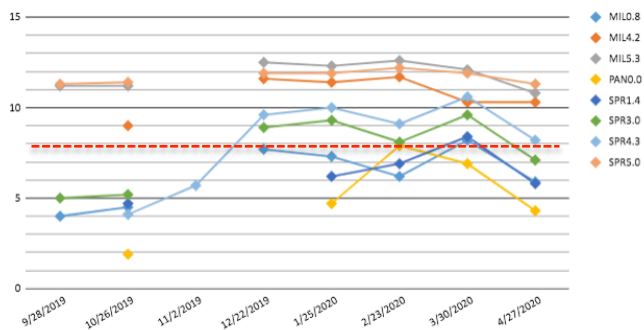
The Washington State standard for northwest rivers and streams states that dissolved oxygen should be 8 mg/L or higher (represented by the dashed red line in the chart below). Adult salmon do best at these levels but salmon eggs in gravel (which would typically be present between October and January) typically require 11 mg/L. Based on the wet season results, stations PAN0.0, SPR1.4, & MIL0.8 (the lowest stations in the watershed) were almost at or often below Washington Standards for dissolved oxygen. In the dry season, dissolved oxygen levels declined at all sites. Sites with the highest levels were located high in the watershed (SPR5.0 & MIL5.3). MIL4.2 only dropped slightly below the State Standard in September. All other sites were nearly at or completely below the State Standard throughout the dry season, with PAN0.0 having the lowest oxygen levels (1.9 mg/L or less), followed by MIL0.8 (4 mg/L or less), SPR1.4 (6.4 mg/L or less), SPR3.0 (7.1 mg/L or less), and SPR4.3 (8.1 mg/L or less).

Figure 2: Wet Season Dissolved Oxygen (mg/L) Results

The amount of oxygen dissolved in water is affected by water temperature, as warmer water has less oxygen. While water temperature was within acceptable ranges during the wet season, it is clear that parts of the creek have limited to almost no riparian vegetation to provide shade to the water and water temperatures at some site in April were starting to approach the State Temperature Limit (water temperatures should be  $\leq 17.5$  °C). In the dry season, water temperature increased at all the sites, with three sites going above state temperature limits (MIL0.8, SPR1.4 & SPR3.0) in May and MIL0.8 doing so again in July. High nutrient content in the water can lead to low dissolved oxygen because nutrients encourage plant growth but in the fall plants start to die off and are consumed by other organisms, causing oxygen to be removed from the water. Nitrate levels were generally between Excellent and Fair during the Wet and Dry Seasons, but other forms of Nitrogen and Phosphorous were not tested, so it was impossible to understand the full scope of nutrients entering the creek. Low and/or stagnant

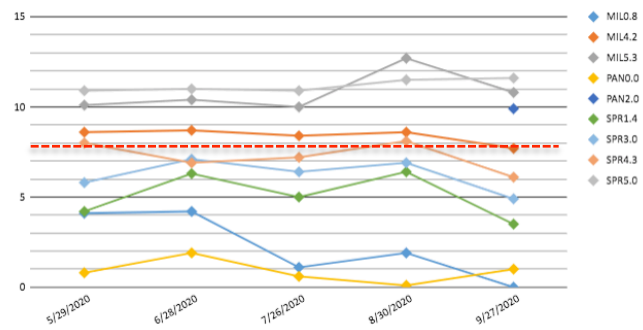
Figure 3: Dry Season Dissolved Oxygen Results

water flows and a lack of turbulence can also lower the dissolved oxygen in the creek and this may be the case as much of the lower part of the watershed is quite flat and water flow was often slow to moderate at best. The Black River Dam/Pump Station contributes to lower flows and stagnation in the lower basin as well. According to staff from the City of Renton, Panther Creek, after it passes under Highway 167, has significant stagnation problems, which likely contributed to low oxygen in the creek. High levels of Iron bacteria found throughout the watershed but particularly in Panther Creek can also consume oxygen and may contribute to low levels. Other pollutants in stormwater that wash into the stream during the winter may also impact dissolved oxygen levels but this was beyond the scope of the current project to evaluate.

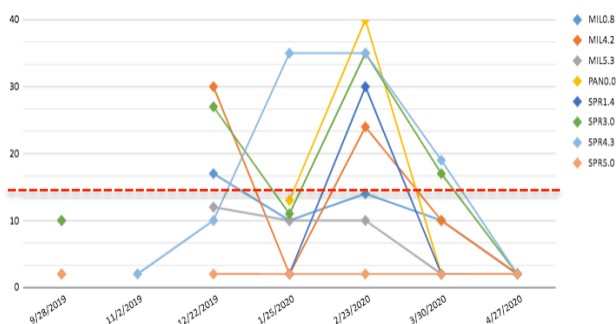
Turbidity is the cloudiness or haziness of a fluid caused by suspended solids floating in the water and is measured in units called nephelometric turbidity units or "NTUs." Due to winter rains bringing more sediment into the creek, we expect to see higher turbidity levels in the wet season. Turbidity was an issue at a few locations between December and March. For Salmon and according to Washington State standards, turbidity should not be more than 5 NTU over the normal background level of turbidity (which for Springbrook Creek should be approximately 10 NTUs). During the Wet Season, six of the middle and lower stations in the Watershed (PAN0.0, SPR1.4, SPR3.0, SPR4.3, and MIL4.2) were often above this level (i.e. >15 NTU) at different times during the wet season: in October (PAN0.0); in December (SPR3.0, MILO.8 & MIL4.2); in January (SPR4.3); in February (PAN0.0, SPR1.4, SPR3.0, SPR4.3, & MIL4.2), and in March (SPR3.0 & SPR4.3). During the Dry Season, when there is generally fewer rainfall events, we expect the waters of Springbrook to be clearer and have lower turbidity levels. Results showed that this was generally true for most sites except Panther Creek. PAN0.0 had consistently higher turbidity levels than even its winter values perhaps caused by or worsened by high levels of iron bacteria that give an orange color to the water (see photos below). Its highest turbidity level was 90 NTUs in August. MILO.8 also had somewhat elevated turbidity levels with its high reading of 27 NTUs in August as well.

Figure 4: Wet Season Turbidity (NTUs) Results

Water with high turbidity levels can clog fish gills and suffocate them. The particles in highly turbid water also attach to other pollutants, such as metals and bacteria. Most creeks, urban or not, usually have near zero turbidity outside of rain events. Six of the middle and lower Springbrook Creek stations had higher turbidity during the wet season. High stormwater flows can bring in more pollution from the surrounding land to the creek or re-suspend the sediments in the creek. During the dry season, two sites (PAN0.0 from June through September & MILO.8 in August) still had high turbidity. Panther Creek turbidity was higher than in the wet season and the creek is heavily impacted by Iron bacteria that is present throughout the watershed, which may play a more significant role in its turbidity issues than rain events.

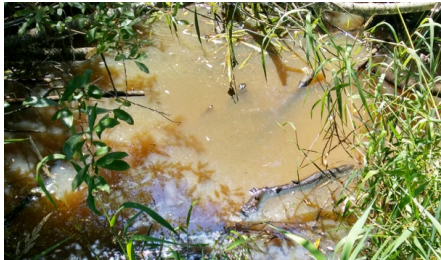
Figure 6 & Figure 7: During the dry season water at Panther Creek (PAN0.0) had high turbidity and an orange color cause by Iron Bacteria

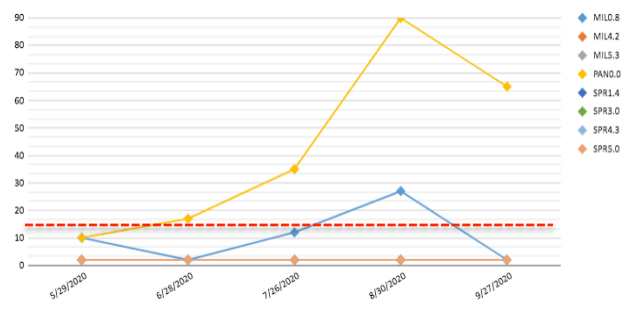
Figure 5: Dry Season Turbidity (NTUs) Results

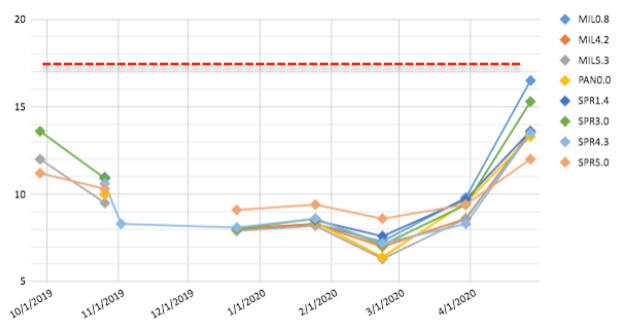
The Washington State Temperature Limit for surface waters should always be  $\leq 17.5^{\circ}\text{C}$ . During the wet season, temperatures achieved this. Temperatures in the wet season ranged from  $6^{\circ}\text{C}$  (in February 2020) to  $17^{\circ}\text{C}$  (in April 2020). During the dry season, temperatures ranged from  $11.9^{\circ}\text{C}$  (in September 2020) to  $19.6^{\circ}\text{C}$  (in May 2020). Three sites exceeded the State temperature standard: MIL0.8 ( $19.6^{\circ}\text{C}$  in May and  $19.2^{\circ}\text{C}$  in July), SPR1.4 ( $19.2^{\circ}\text{C}$  in May) and SPR3.0 ( $17.7^{\circ}\text{C}$  in May).

Figure 8: Wet Season Temperature (degrees C) Results

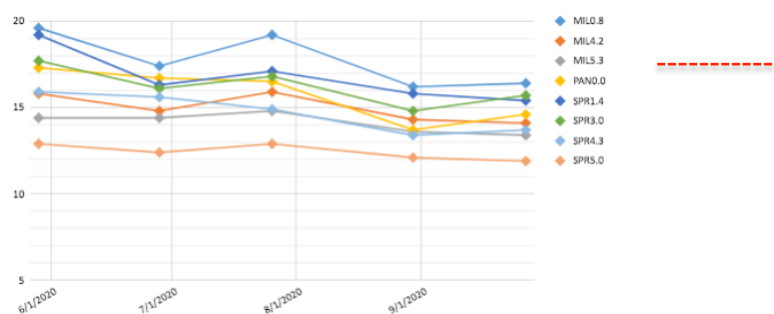
Figure 9: Dry Season Temperature (degrees C) Results

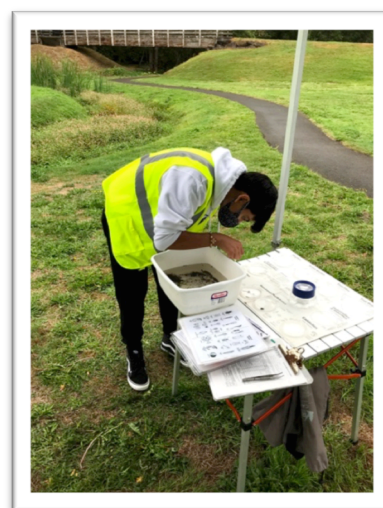
Figure 10: UTB Intern doing bioassessment

At the five locations where biological assessments were done on September 5<sup>th</sup> 2020, the number of different invertebrate species (bugs) living in the stream were counted, which is an important measurement of the streams biological diversity. Invertebrates were classified and counted into one of three groups: Group I were bugs that indicate good to excellent water quality, since they are more sensitive to pollution; Group II were bugs that indicate fair water quality, and Group III were bugs that rate the stream's biological diversity as poor, as these were pollution tolerant species.

The number of species types or taxa observed were then counted to create an index value for each group and then the sum of all the group index values is calculated to find the **Cumulative Index Value (CIV)** for the stream. This number is then used to provide the stream quality assessment of either Poor (CIV < 11), Fair (CIV 11-16), Good (CIV 15-22), or Excellent (CIV > 22). The following table provides the results for each site surveyed (ranked from highest to lowest CIV value, but also highest to lowest sites in their respective streams).

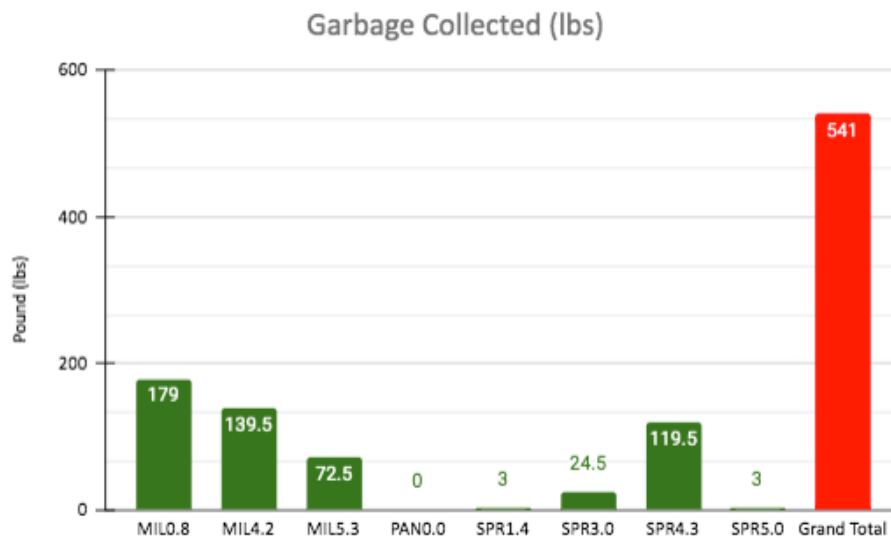
A total of 541 pounds of garbage was collected at the different monitoring locations throughout the year, with the most collected at MIL0.8 (located on the Interurban trail and some commercial buildings near 72<sup>nd</sup> Street), MIL4.2 (located near a Ford Service Station in Kent), and SPR4.3 (located near 192<sup>nd</sup> St in Kent). Also, but to a lesser extent, MIL5.3 (in Mill Creek Earthworks Canyon Park in Kent) had moderate garbage accumulation but this included sharps, which were left in place. Since most of these sites are located in Kent, the work was done in collaboration with the Kent Adopt-A-Spot program and the City of Kent Public Works Department picked up all garbage that was collected.

Figure 11: Garbage collected at different sites and overall (in lbs)

For garbage, the finding was that it seemed to accumulate most at those sites that offer easy access to the creek but are also less visible to the public, so that dumping of trash is less noticeable. Trash appears to also accumulate where there is a lack of connectivity in the trail system, such as where the Springbrook Creek Trail ends in Renton on the border with the City of Kent.
